2018 CYPRESS CREEK BASIN HIGHLIGHTS REPORT

*A Summary of Water Quality in
the Cypress Creek Basin in 2017*

PREPARED IN COOPERATION WITH THE TEXAS COMMISSION ON ENVIRONMENTAL QUALITY

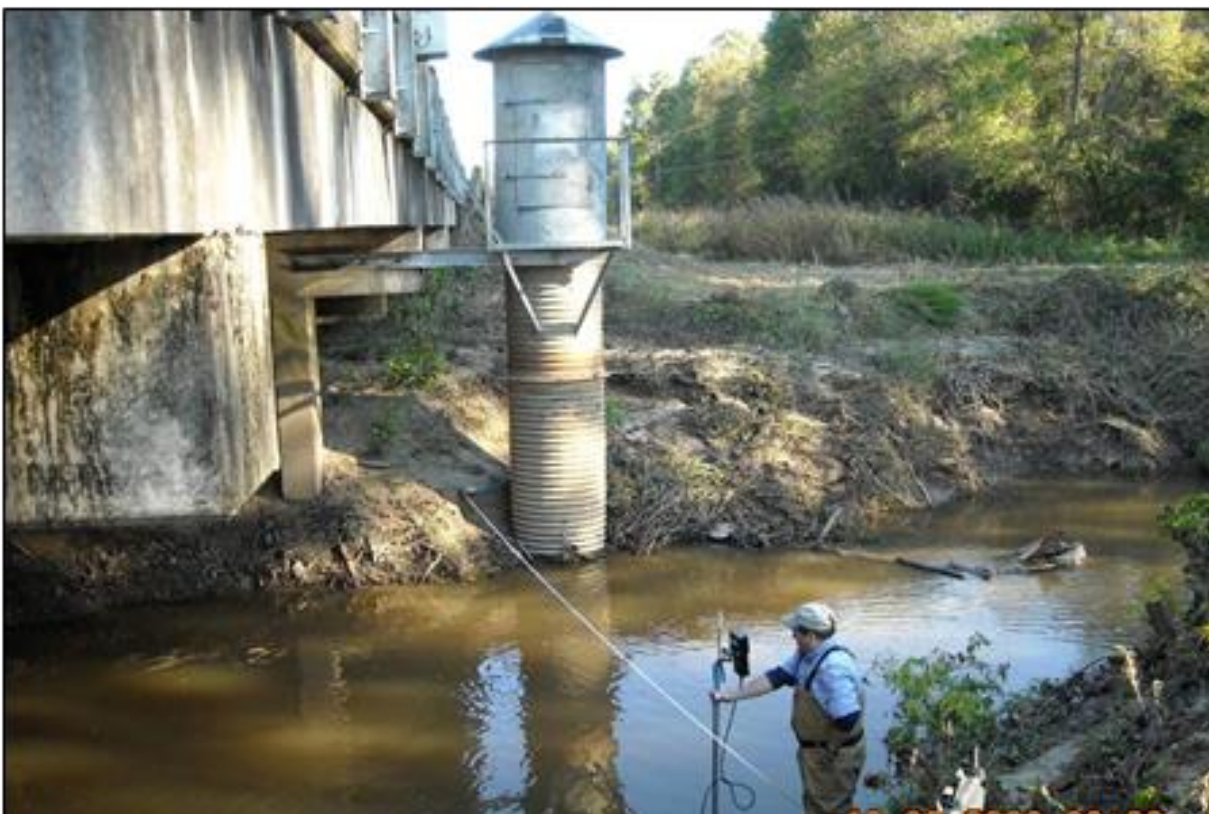
This section of Big Cypress Creek flows through land and grazing pastures. Several poultry operations are located within its watershed. Much of the riparian vegetation along the creek has been removed. Big Cypress Creek was placed on the *Texas §303(d) List* for depressed dissolved oxygen in 2014. A preliminary review of data collected since the 2014 listing indicates that dissolved oxygen in the creek remains low. The 2014 IR also shows a concern for bacteria. Quarterly sampling for flow, bacteria, and for field and conventional parameters at Station 15260 (Big Cypress Creek at SH 37) continues in 2018.

Figure 23: Stream flow measurement on Big Cypress Creek at SH 37
